Quality Assessment Report

Site name:	**Pretoria, South Africa**
Latitude, longitude [°]:	-25.753080, 28.228590
Altitude [m a. s. l.]:	1410
Location on a map:	https://apps.solargis.com/prospect
Type:	Ground measurements
Source:	SAURAN
URL:	https://sauran.ac.za
Attribution:	Brooks, M.J., du Clou, S., van Niekerk, J.L., Gauche, P., Leonard, C., Mouzouris, M.J., Meyer, A.J., van der Westhuizen, N., van Dyk, E.E. and Vorster, F. 2015. "SAURAN: A new resource for solar radiometric data in Southern Africa". Journal of Energy in Southern Africa, 26, 2-10.
Time step:	1 minute
Quality assessment status:	T R M I P

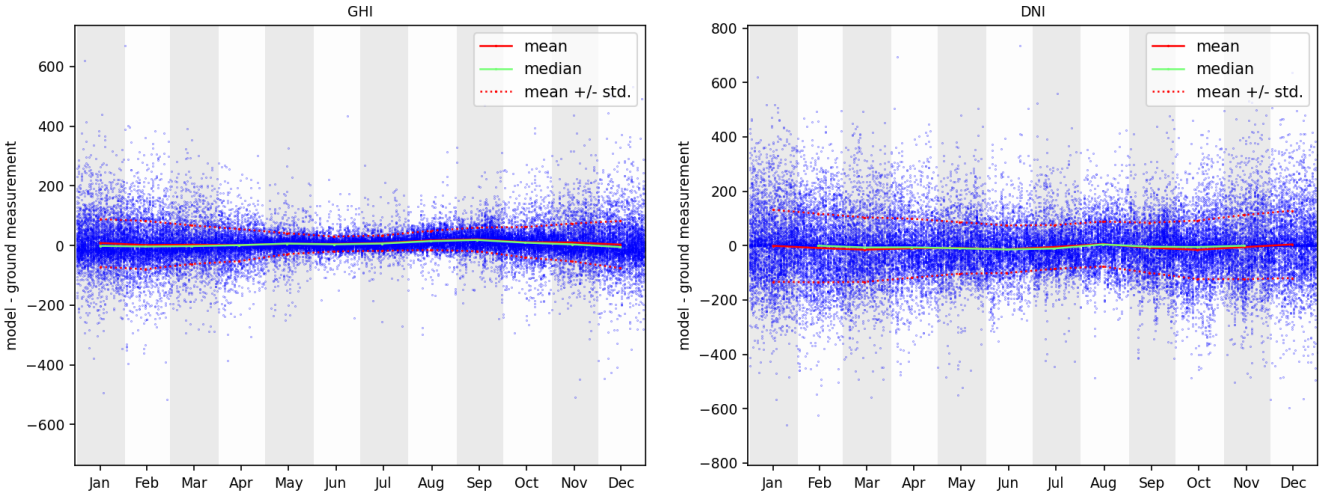
Fig. 7: Deviations of hourly GHI and DNI - Pretoria
X-axis: day of year DOY; Y-axis: difference between model and measurements
